**Sixth Five-Year Review Report
for
Celanese Corporation (Shelby Fibers Operations)
NCD003446721**

**Grover
Cleveland County, North Carolina**

August 2016

**United States Environmental Protection Agency
Region 4
Atlanta, Georgia**

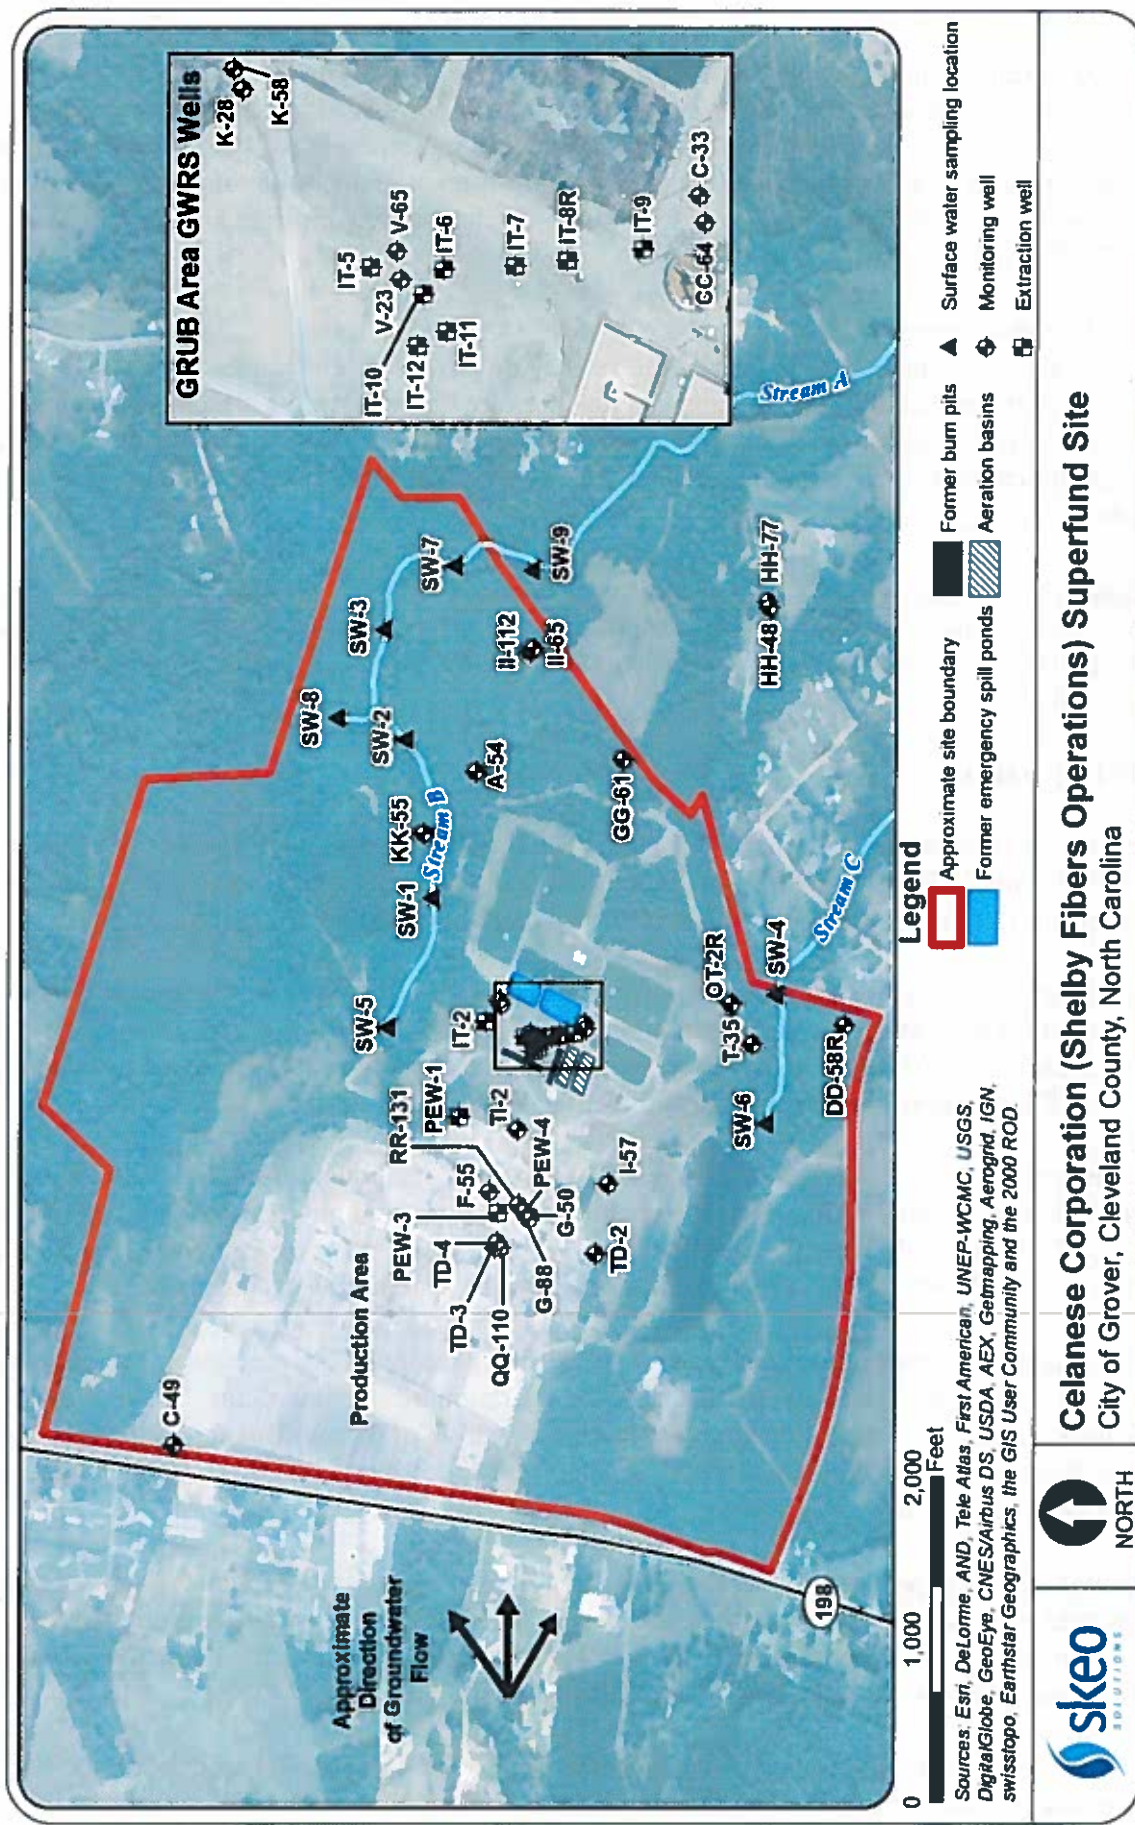
Figure 4: Groundwater and Surface Water Sampling Locations

Between March 2011 and March 2015, concentrations of 1,1-biphenyl, naphthalene and phenol exceeded their respective North Carolina 2L standards only at well F-55 (Figure 4 and Table I-6). DOWTHERM™A is a heat transfer fluid comprised of about 73 percent diphenyl ether and 27 percent 1,1-biphenyl. This dense non-aqueous phase liquid (DNAPL) is routinely found in well F-55, as the use of the fluid in previous facility operations impacted the well. In general, since March 2011, 1,1-biphenyl, naphthalene and phenol concentrations tend to fluctuate at F-55, with no significant trends observed.

When detected during sampling events, AECOM measures the depth of the DNAPL in well F-55. Between June 2006 and March 2011, the thicknesses of DNAPL observed in well F-55 remained relatively stable. Since October 2011, the DNAPL thicknesses measured in well F-55 have shown an overall increase (Table I-7). This increase suggests that MNA and the operation of the GWRS may not be capable of addressing the source of DNAPL at well F-55. It also may indicate an ongoing source of DOWTHERMTMA at or near well F-55.
